Confidential Property Inspection Report of:

8466 Golden Fields Ln, Loveland, CO 80538

Inspected on: August 13, 2007.

Re: General Inspection of 8466 Golden Fields Ln, Loveland, CO 80538

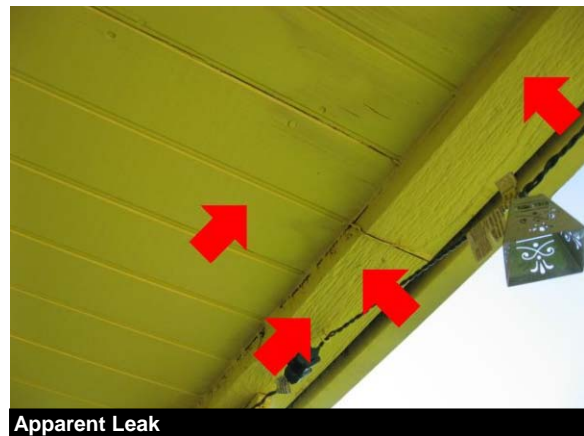
Moisture stains observed from upper deck.
Apparent membrane material observed through upper deck board.- stains suggest roofing membrane has leak or may currently leak.
Apparent isolated moisture damage/rot. No active moisture measured at the time of the inspection - monitor and evaluate further.

Monitor: We recommend monitoring the condition for further development and subsequent maintenance and/or repair needs to sustain the system/material for normal or expected use.

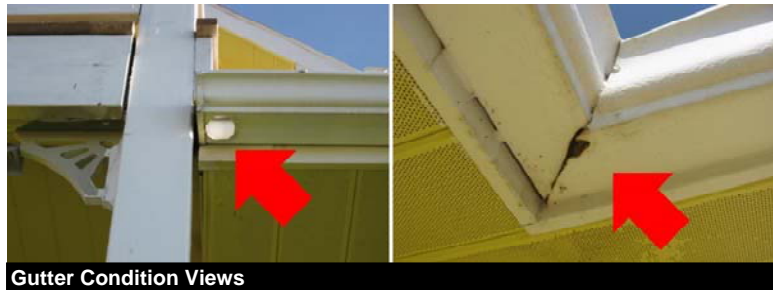
Gutter Condition Views

Gutter system appears to be leaking or likely to leak over south side upper deck. - Repair.

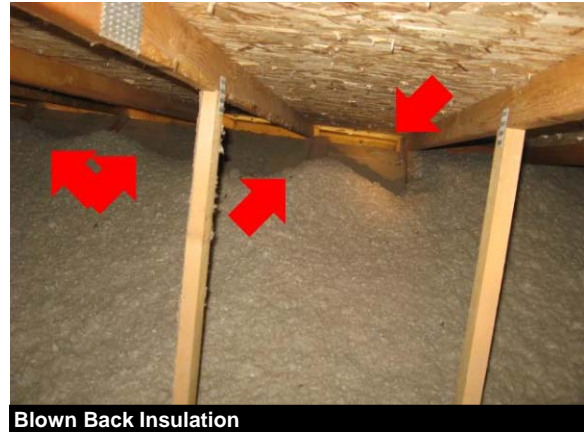
Areas of insulation is uneven/disturbed and no longer provides an even thermal barrier. Significant areas at eaves where insulation appears to have been blow back and clear from full ceiling coverage - unfavorable/improper - recommend re establishing proper insulation

coverage with consideration to soffit vent baffles to possible minimize wind impact on blown insulation - batt insulation may also be considered to manage wind blown insulation

Recommendations: **Improper/Unfavorable Condition:** The apparent condition appears improper or unfavorable. We recommend correcting/improving the situation to minimize the risk of potential related safety and/or serviceable problems. An **appropriate person** may need to be consulted for corrective options and competitive bids.

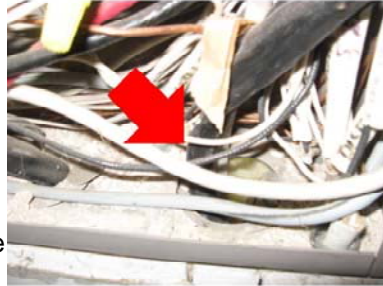
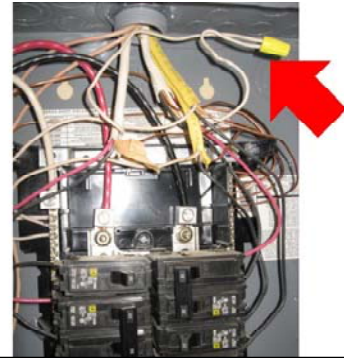
Electrical Panel Condition Views

Appears generally serviceable.
Limited breaker labeling - improper
Missing strain relief clamp. - improper
Subpanel appears bonded (neutral and ground bus bars connected to each other). - improper
Subpanel does not appear to be bonded to the box - - improper- evaluate further

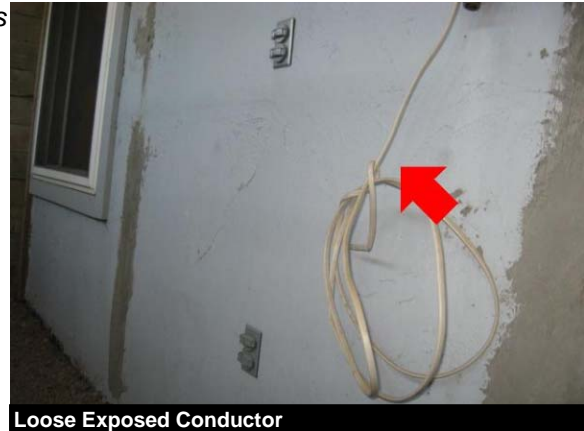
Loose Exposed Conductor

Exposed electrical conductor in basement enclosed room under deck, - evaluate further - for purpose or proper abandonment

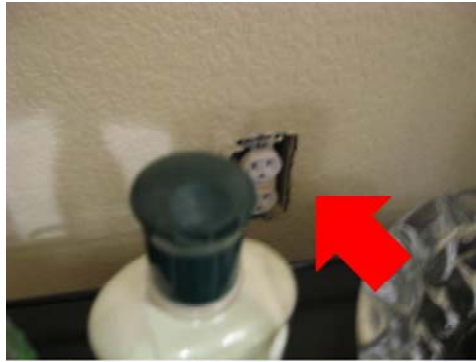
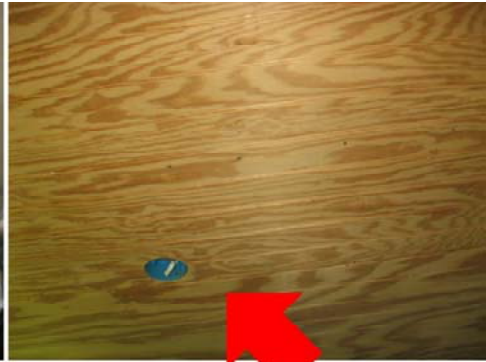
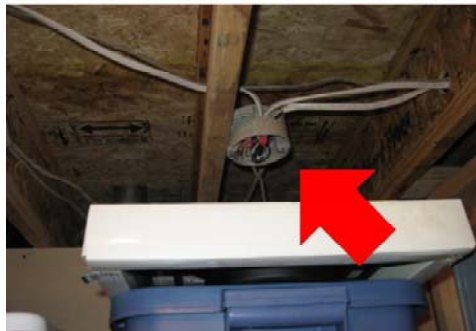
Open Recptacle & Junction Boxes

Loose chord at south side of pond.
Open switch/receptacle boxes, missing cover plates in basement bathroom, basement room under deck and storage room
Loose exterior west side light fixture and missing top cover/lid at south side
Electrical receptacle appears to have an open ground (not properly grounded) at laundry utility sink - improper

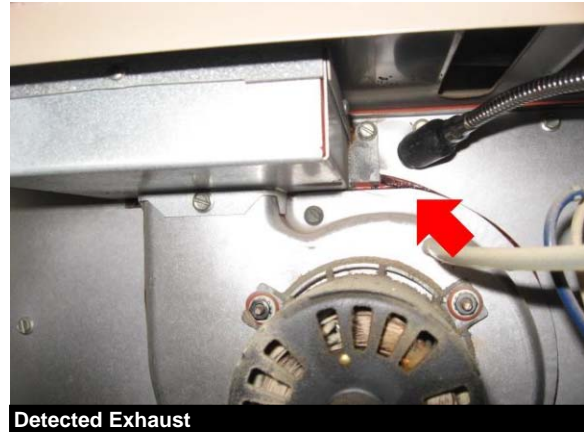
Detected Exhaust

Combusted gas leak (exhaust fumes) detected with TIFF 8800 gas detector at induction fan interface seal with cabinet - evaluate further - safety hazard
