## Confidential Property Inspection Report of:

**2962 Spring Mtn Dr, Loveland, CO**

**Inspected on: 10/27/2005**

Re: General Inspection of 2962 Spring Mtn Dr, Loveland, CO

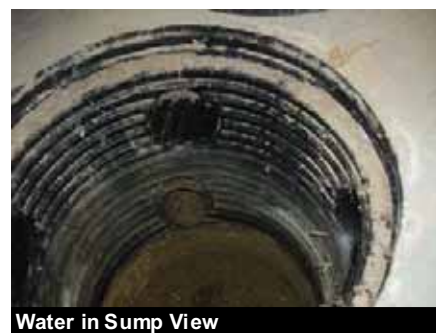
**Water in Sump View**

Standing water observed or stains from past water collection. A pump is recommended. Floor drain appears serviceable.

**Upgrade:** We suggest upgrading the system/components to improve the safety and/or serviceable condition.

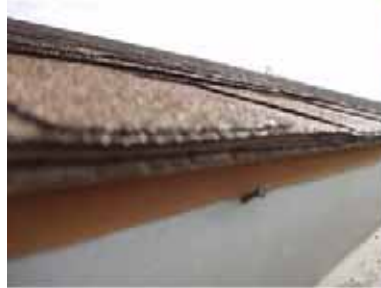
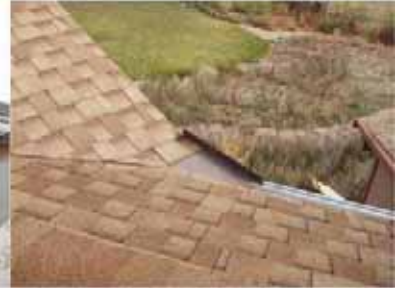
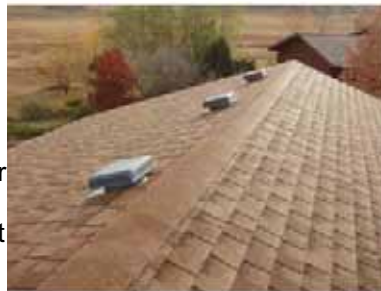
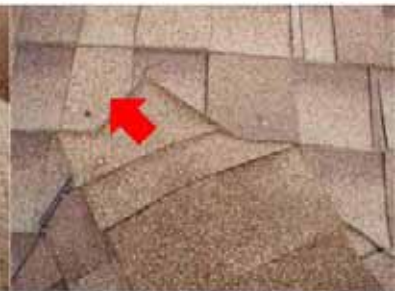
Roof Views, Exposed Nails

Appears generally serviceable with typical aging signs of weathering/cracking/curling. Some exposed (non-hidden) nails observed without caulk/sealant. Caulking/sealing exposed nails is common and recommend practice to reduce the risk of moisture penetration.

**Monitor:** We recommend monitoring the condition for further development and subsequent maintenance and/or repair needs to sustain or preserve the system/component for normal or expected use.

**Maintenance:** We recommend maintaining the system/material to minimize increased deterioration. Routine or expected maintenance will help sustain or preserve normal and expected use.

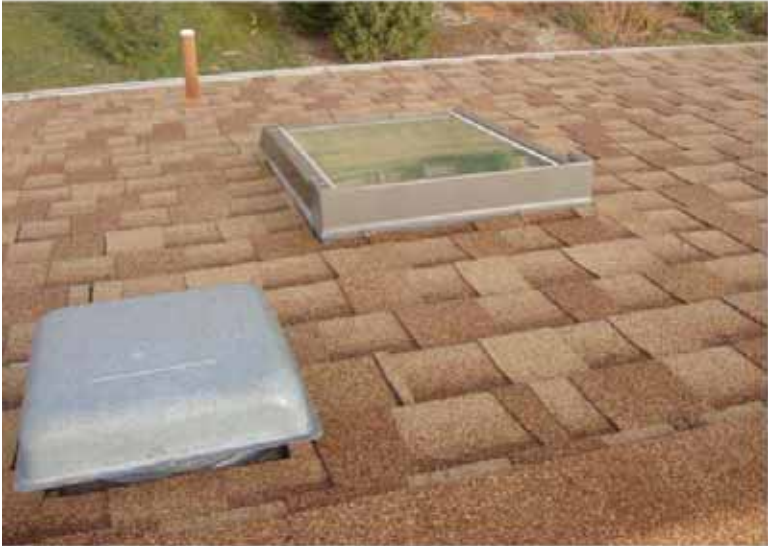
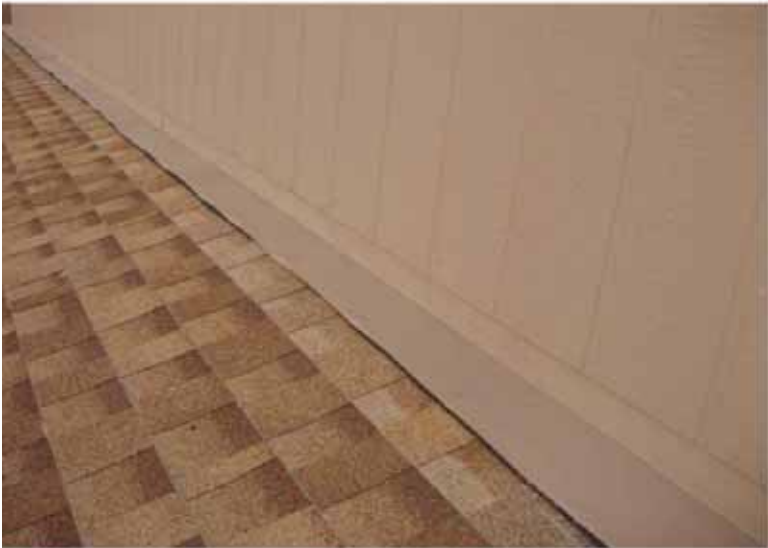
**Flashed Area Views**

Observations:  
Appears generally serviceable.

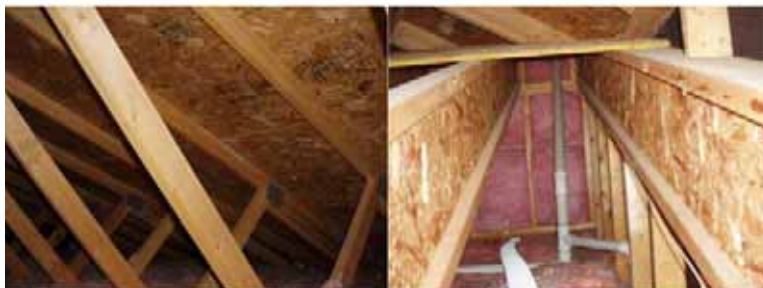
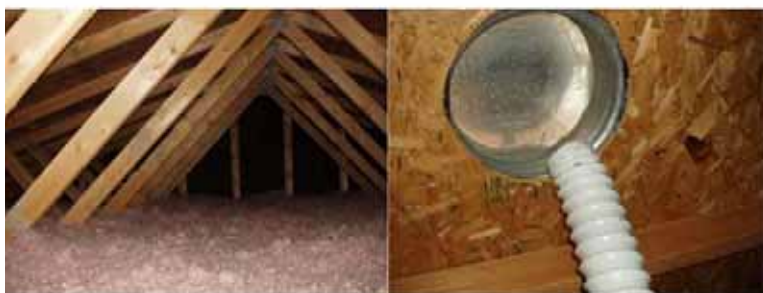
**Attic Views**

Appears generally serviceable.  
Apparent bathroom vent terminated at attic vent monitor  
Ventilation is provided.

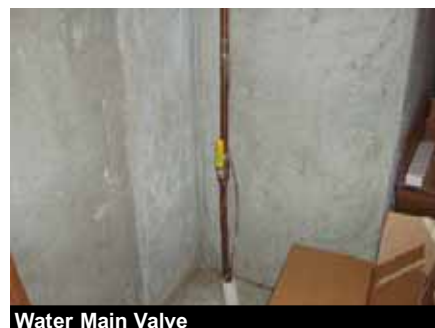
Water Main Valve

Valve observed - Not Tested. Water pressure appears serviceable, measured at ~ 58 psi at faucet.
