Confidential Property Inspection Report of:

4624 Foothills Dr, Loveland, CO

Inspected on: 11/14/2005

Re: General Inspection of 4624 Foothills Dr, Loveland, CO

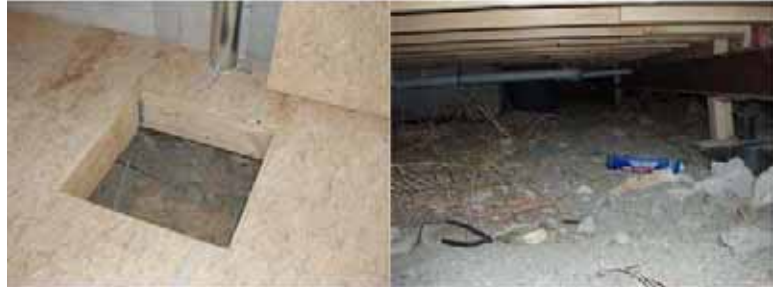
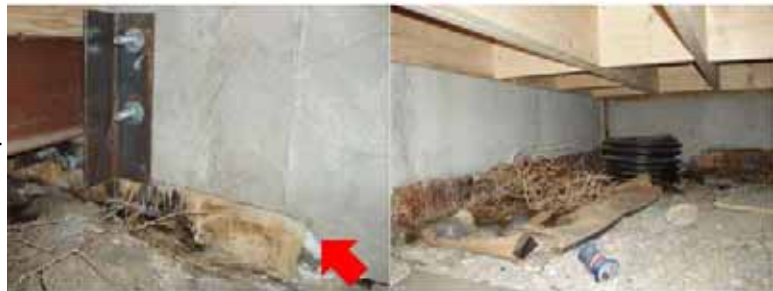
Crawlspace Views, Decaying Cardboard

Isolated decaying cardboard within crawlspace area. People with sensitivities to organic decay and fungus should note that this is common for a foundation wall on caissons footings to have cardboard material used to fill concrete voids as part of the forms. These fillers are designed to naturally decay in place. As part of that process fungus activity takes place and is generally controlled by the venting system.

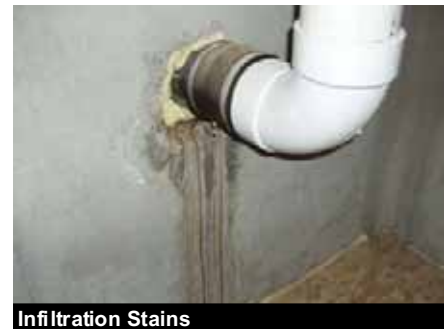
Infiltration Stains

Appears generally serviceable. Typical to moderate cracks with potential for moisture penetration. Proper caulking/sealing will help maintain and protect the system. Isolated wall staining observed with efflorescence (white powder, evaporative minerals from water seepage and evaporation) seen on walls indicates the presence of periodic moisture. Also see comments on Exterior Grading and Gutters and Downspouts, for applicable observations and recommendations.

Stains under sewage waste line pipe penetrating foundation wall - may be from construction period or periodic moisture build-up around foundation - monitor.

Monitor: We recommend monitoring the crack and staining condition for further development and subsequent maintenance and/or repair needs to sustain or preserve the system/component for normal or expected use.

Maintenance: We recommend maintaining the crack system/material to minimize increased deterioration. Routine or expected maintenance will help sustain or preserve normal and expected use.

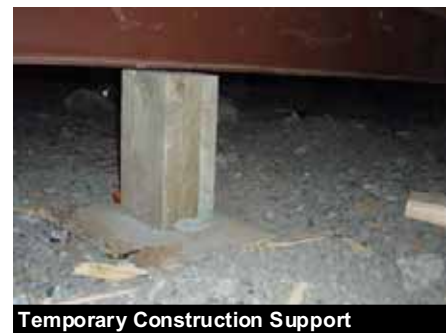
Temporary Construction Support

Temporary wood construction supports left in place - recommend removing.

Improper/Unfavorable: The apparent temporary construction supports condition appears improper or unfavorable. We suggest correcting the situation.

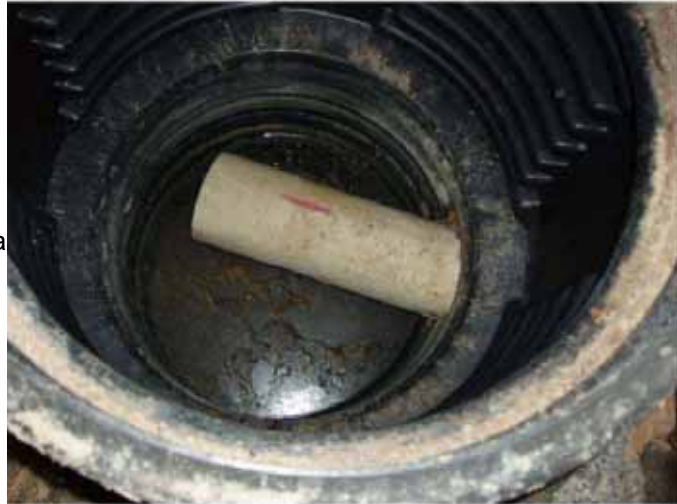
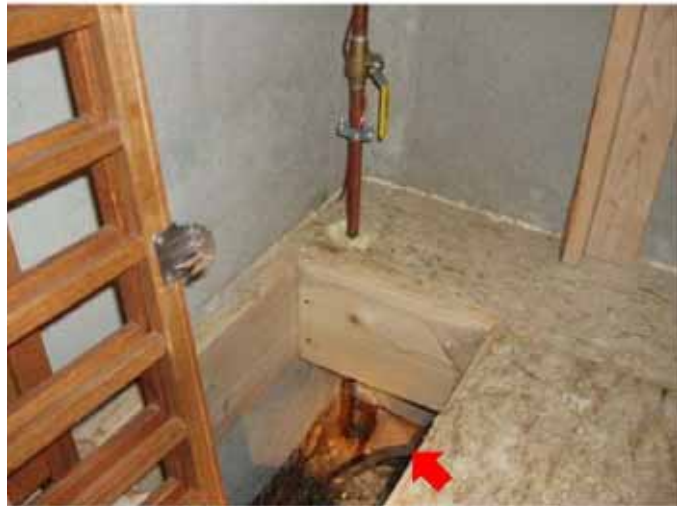
Sump Area and System

Standing water observed or stains from past water collection. A pump is recommended.

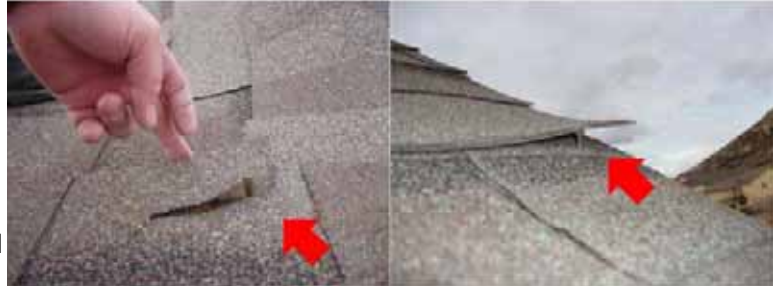
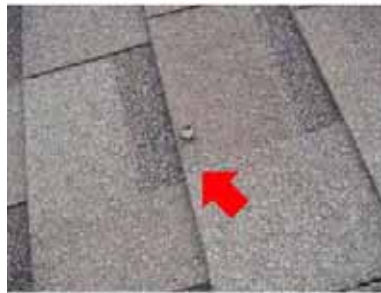
Isolated Roof Issues

Appears generally serviceable with one isolated damaged/torn shingle noted at east side near lower ridge.

Some shingle lifting noted.

Outer exposed edge of composition shingles are typically secured down by an adhesive. High winds, dust and dirt can loosen and work their way up under shingles. Routine monitoring and maintenance will help address this condition before it can cause more significant damage/problems.

An observed nail are protruding from the roof surface. This condition can cause roof leaks and loss of shingles. Proper maintenance/repair of protruding nails is advised.

Some exposed (non-hidden) nails observed without caulk/sealant. Caulking/sealing exposed nails is common and

recommend practice to reduce the risk of moisture penetration.

Maintenance: We recommend maintaining the system/material to minimize increased deterioration. Routine or expected maintenance will help sustain or preserve normal and expected use.

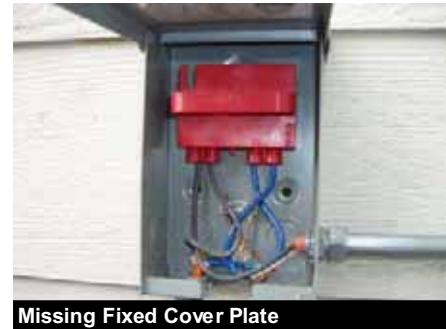
Missing Fixed Cover Plate

Missing disconnect panel fixed cover plate at AC exterior disconnect box. - Improper and potential safety hazard.

Improper/Unfavorable: The apparent condition appears improper or unfavorable. We suggest correcting the situation with an installed fixed cover plate.

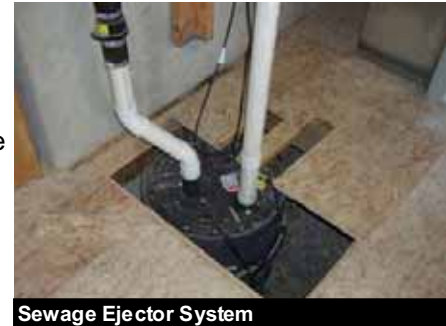
Sewage Ejector System

Sewage Ejector system noted - When waste drain pipes are below the level of the main building sewer drain these systems will collect the lower level waste water & sewage into an enclosed sump and lift the waste sewage to a level suitable for gravity drainage into the main sewer line. Appears generally serviceable. However, no active plumbing in basement to test pump - Monitor/Evaluate further.

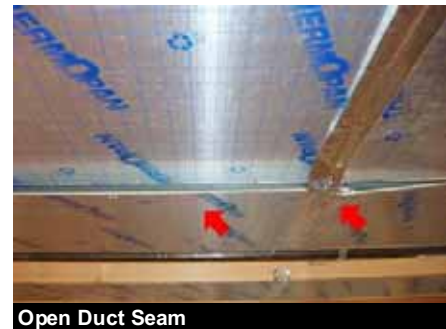
Appears serviceable, with isolated loose return air foil covered board near furnace - maintain.

Maintenance: We recommend maintaining the heating system per manufacture recommendations. Routine or expected maintenance will help sustain or preserve normal and expected use.
