Confidential Property Inspection Report of:

8595 W. 67th Place, Arvada, CO

Inspected on: 05/08/2006

Re: General Inspection of 8595 W. 67th Place, Arvada, CO

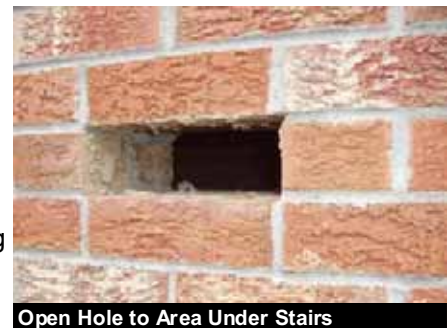
Open Hole to Area Under Stairs

Improper/Unfavorable: The apparent condition appears improper or unfavorable. We suggest monitoring and consideration be given to correcting the situation. An **appropriate person** may need to be consulted.

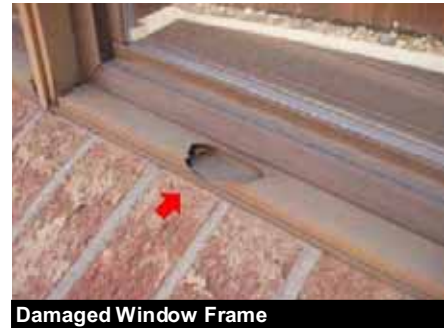
Appears generally serviceable.
Gap in seal around kitchen bay window - maintain
Frame damaged at east side garage window - repair

Maintenance: We recommend maintaining the system/material to minimize increased deterioration. Routine or expected maintenance will help sustain or preserve normal and expected use.

Repair: We suggest repairing the condition to avoid problems associated with the current situation. We recommend the work be performed by an appropriate person/company and obtaining competitive bids with consideration to proper corrective options.

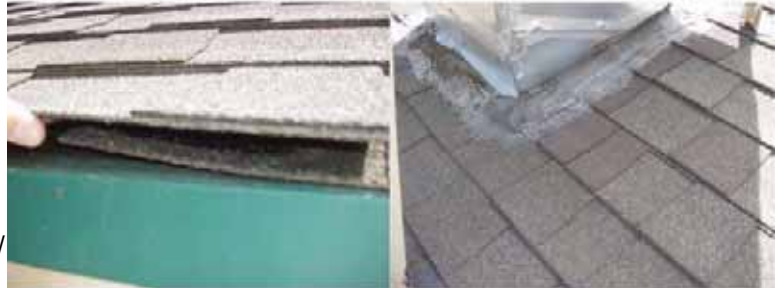
Roof design appears to have two roof slopes meet in a wide valley with potential poor drainage. This type of design may cause ice damming and roof leaks under certain conditions. Heat tape, enhanced flashing or roof reconstruction can help prevent/correct the condition, if needed. Homeowners should be aware of the potential condition and monitor for adverse changes. It does appear that the flashing has been built-up in the valley area.

Monitor: We recommend monitoring the condition for further development and subsequent maintenance and/or repair needs to sustain or preserve the system/component for normal or expected use.

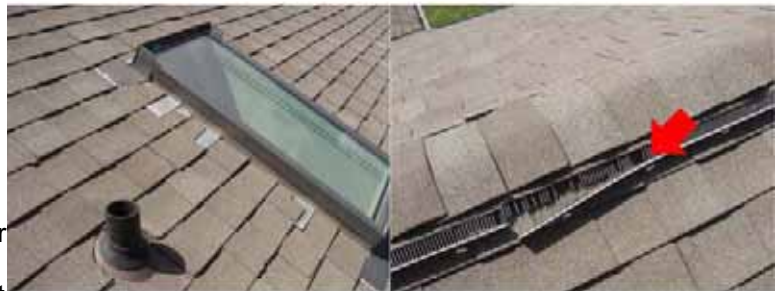
Roof Views, Damaged Ridge Vent

Appears generally serviceable
Some damaged plastic screening at ridge vent.

Repair: We suggest repairing the condition to avoid problems associated with the current situation. We recommend the work be performed by an appropriate person/company and obtaining competitive bids with consideration to proper corrective options.

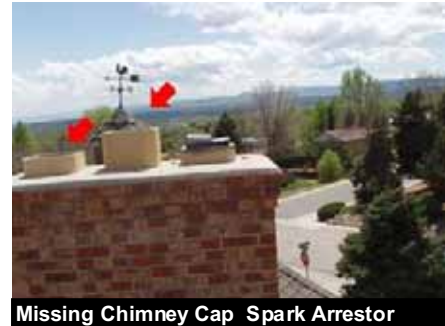
Fireplace - No apparent chimney cap. No apparent spark arrester at chimney. - Generally improper condition for current standards.

Missing Chimney Cap Spark Arrester

Improper/Unfavorable: The apparent condition appears improper or unfavorable. We suggest improving/correcting the situation. An **appropriate person** may need to be consulted.

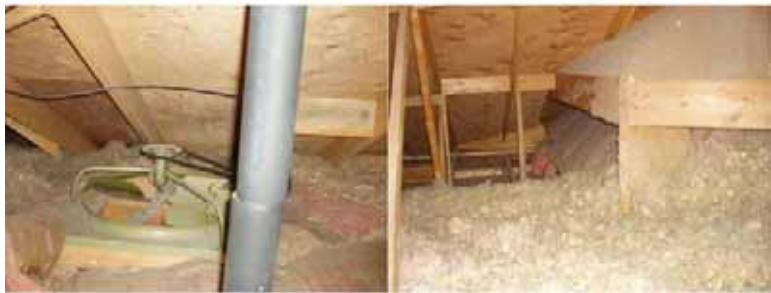
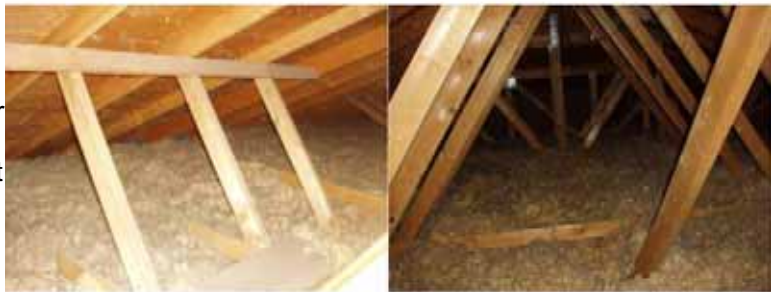
Attic Views

Ventilation is provided.
Minor stains are noted. They do not appear active at the time of the inspection. May be from past roof condition - consult seller/monitor

Monitor: We recommend monitoring the condition for further development and subsequent maintenance and/or repair needs to sustain or preserve the system/component for normal or expected use.

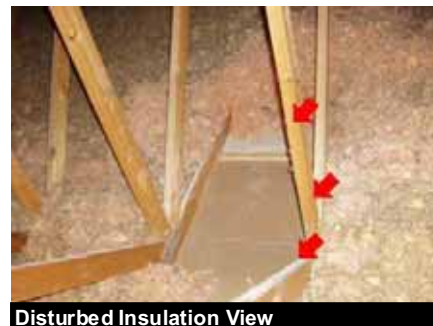
Areas of insulation is uneven/disturbed and no longer provides an even thermal barrier. Missing insulation over kitchen area.

Disturbed Insulation View

Improper/Unfavorable: The apparent condition disturbed insulation appears improper or unfavorable. We suggest consideration be given to correcting/improving the situation. An **appropriate person** may need to be consulted.

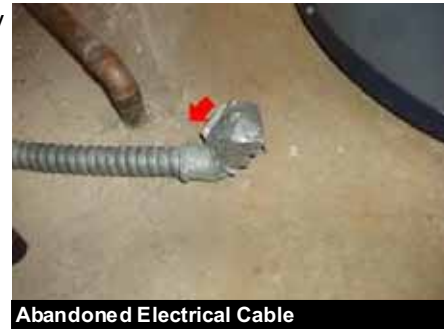
Some abandoned or disconnected wiring is found near water heater, ensure proper disconnect from power
Dining room fan off balance.

Improper/Unfavorable: The apparent condition appears improper or unfavorable. We suggest improving/correcting the situation. An **appropriate person** may need to be consulted.

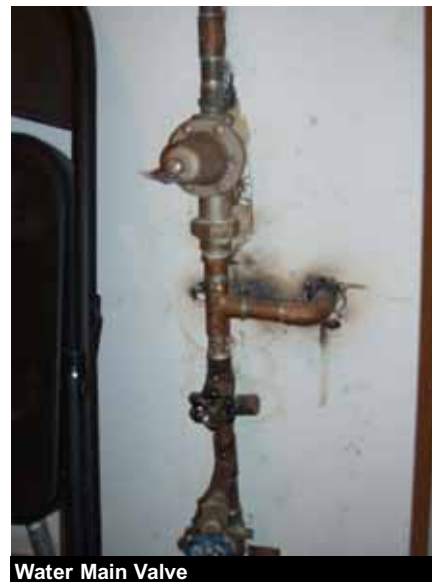
Water Main Valve

Valve observed - Not Tested. Note: Pressure regulator installed.

Water pressure appears serviceable, measured at approximately 56 psi at faucet.
