Confidential Property Inspection Report of:

8466 Golden Fields Ln, Loveland, CO 80538

Inspected on: August 13, 2007.

Re: General Inspection of 8466 Golden Fields Ln, Loveland, CO 80538

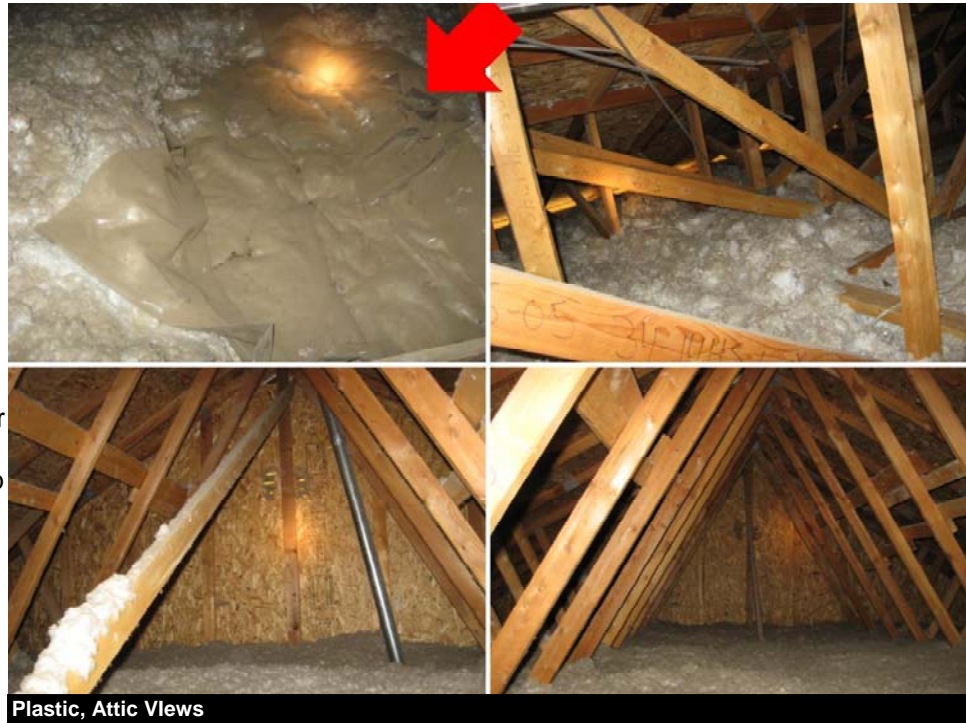
Appears generally serviceable.
Ventilation is provided - Proper
Evidence of rodent intrusion over garage area - maintain.
Sheet of plastic over area of in insulation under furnace/water heater flue - no observed evidence of current or past leaking - there may have been an isolated occurrence of moisture around flue - consult seller on history monitor
