## Confidential Property Inspection Report of:

**2962 Spring Mtn Dr, Loveland, CO**

**Inspected on: 10/27/2005**

Re: General Inspection of 2962 Spring Mtn Dr, Loveland, CO

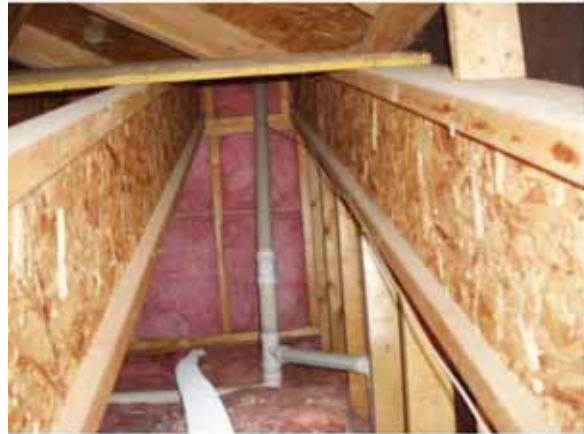
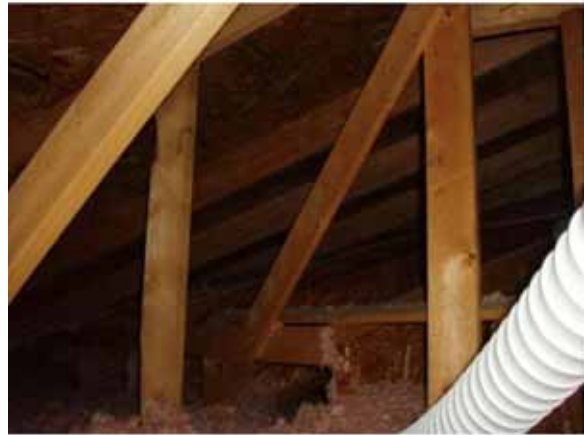
**Attic Views**

Appears generally accessible.  
Inspection observations limited by low head space.

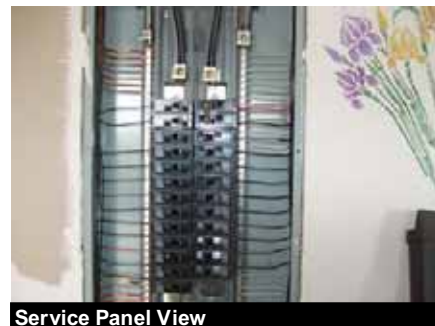
SERVICE PANEL LOCATION:  
Within the garage.

Circuit breaker system. Voltage Rating- 120/240 volts (three-wire service), Amperage Rating- 150 amps.
